F I N A L R E P O R T

POLYMER CONCRETE BRIDGE DECK  
OVERLAY NEAR MURTAUGH, IDAHO

Idaho Transportation Department  
Research Section  
Research Project 96

August 1982

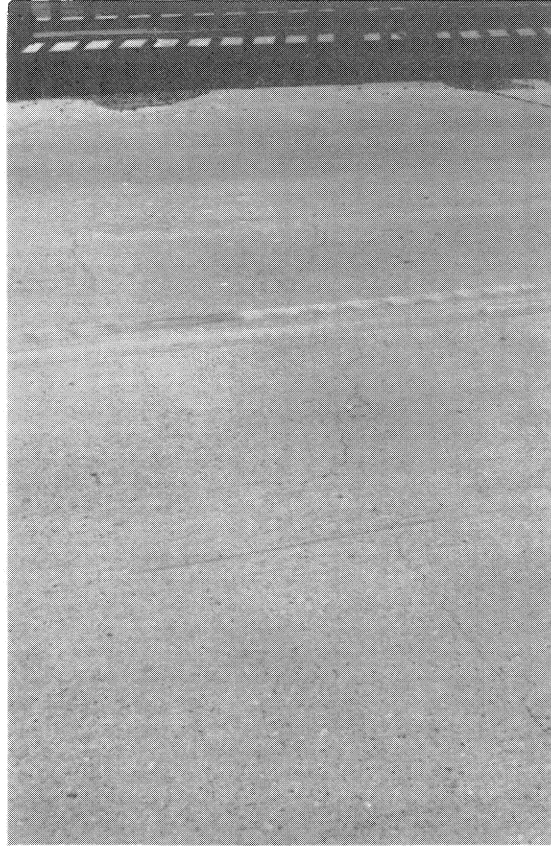
3. Close-up of deck and crack pattern.

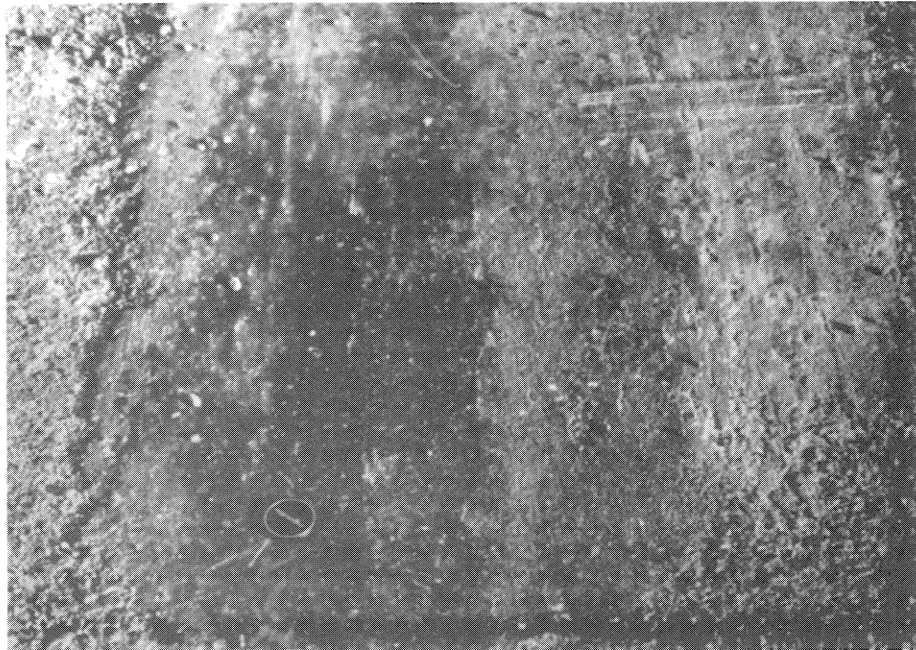
14. Texture of finish material 1978.

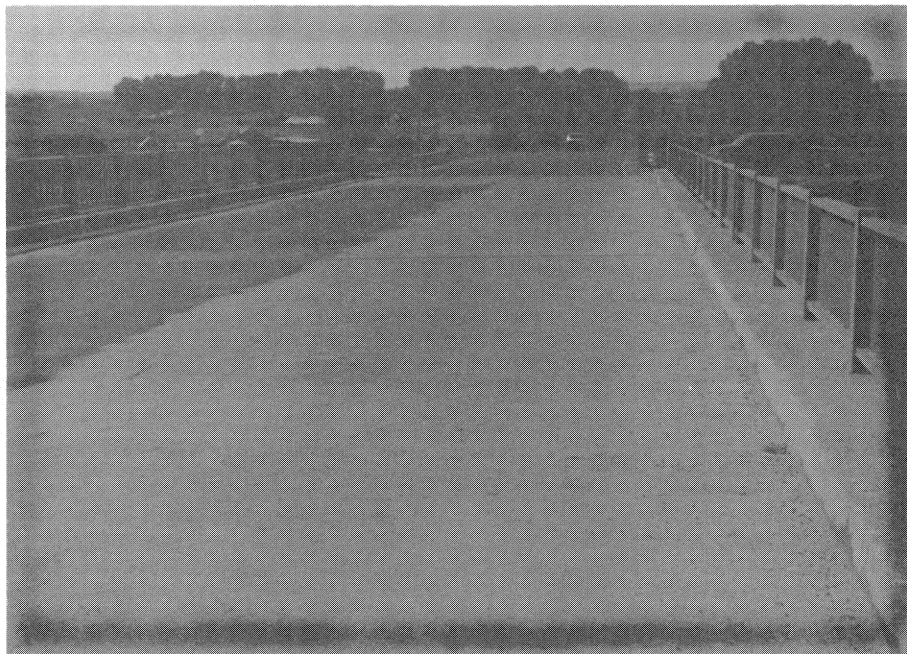
31. Bridge deck after three months Type "B" rt overlay lt

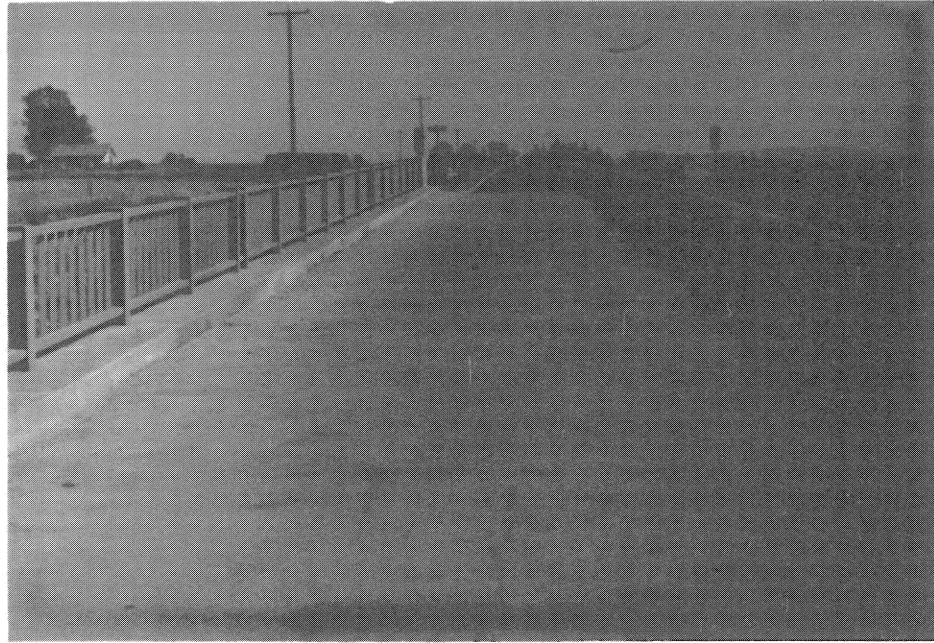
32. Bridge deck after three months.

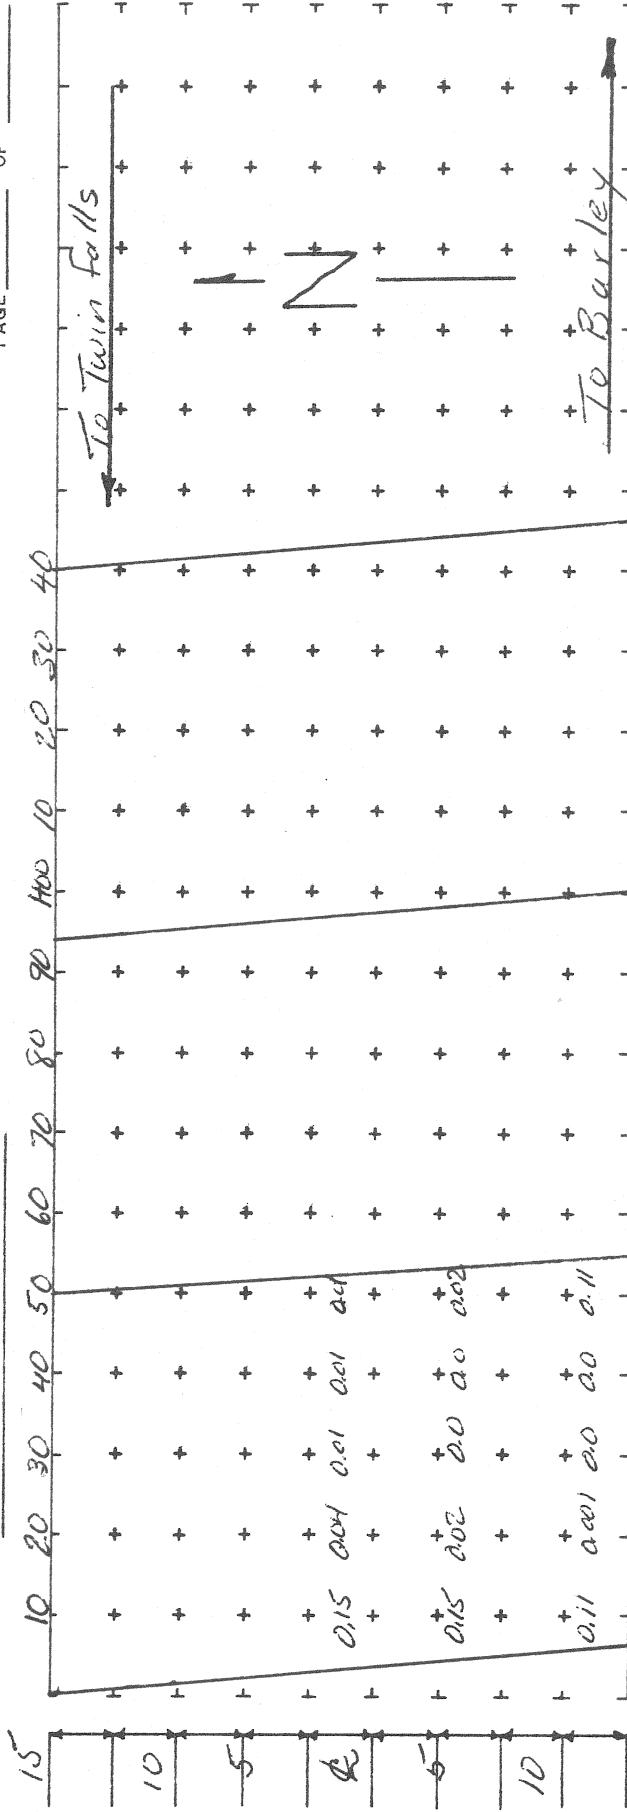
PROJECT NO. R.P. 96 LOCATION Alma Canal DATE CONSTRUCTED 1956 DATE OVERLAYED 1981

Chain Drag

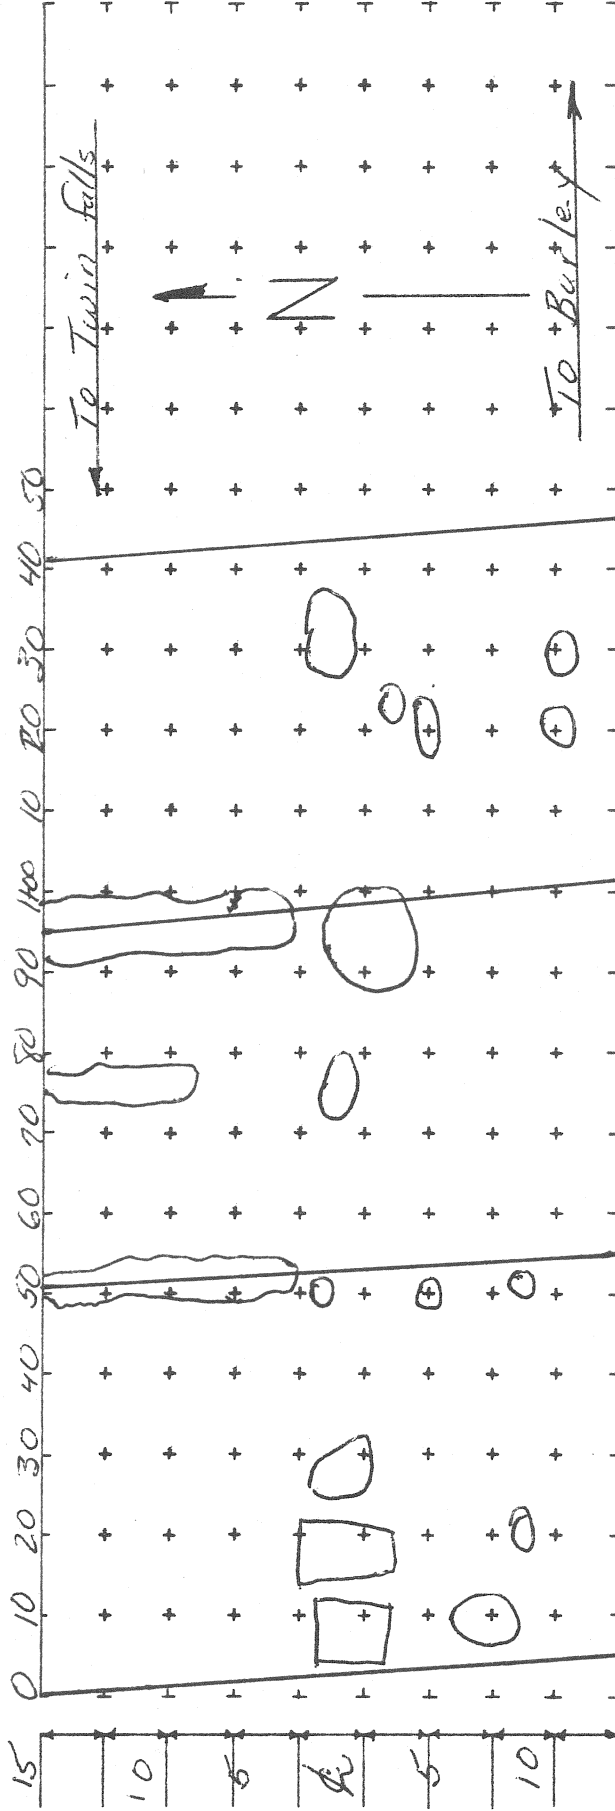
The deck was checked for delamination and cracks. The areas of problems have all grown and show more cracking and delamination. A half cell and resistivity test was attempted, but was not meaningful so it was not completed. The delaminated and cracked areas show very poor results while the good parts show excellent results. The bridge layout record is in Appendix B.

The delamination and debonding is growing. The areas start near a patch or edge so environmental changes are assumed to be the major cause.

PROJECT NO. R.P. 96 LOCATION Main Canal DATE CONSTRUCTED 1956 DATE OVERLAYED 1981  
 No. OF SPANS 3 SPAN LENGTH 46' TYPE OF CROSSING water-way LANE 2  
 DATA UNITS IN: OHMS/VOLTS WEATHER Cold windy  
 REMARKS: 4 0 show delaminated areas
